Service Bulletin

Product :	Note PC	Bulletin No. :	07-HW-10-02
Model :	R70	Bulletin Date :	2007-10-17
Operation Subject :	ASC (<input type="radio"/>) Call center (<input type="checkbox"/>)	ECN Date :	-
Service Type :	Return w/o repair (<input type="checkbox"/>) Scrap after swap (<input type="checkbox"/>) Rework (Repair) locally (<input type="radio"/>)		
Subject :	No power. add insulator on Bottom

Product :	Note PC	Bulletin No. :	07-HW-10-01
Model :	R70	Bulletin Date :	2007-10-17
Operation Subject :	ASC (<input type="radio"/>) Call center (<input type="checkbox"/>)	ECN Date :	-
Service Type :	Return w/o repair (<input type="checkbox"/>) Scrap after swap (<input type="checkbox"/>) Rework (Repair) locally (<input type="radio"/>)		
Subject :	Blue screen reported. add insulator on MBD

Product : Note PC	Bulletin No. : BA020070B35
Model : R70, Q40+	Bulletin Date : 2007-09-13
Operation Subject : ASC (<input type="radio"/>) Call center ()	ECN Date : 2007-08-22
Service Type : Return w/o repair () Scrap after swap () Rework (Repair) locally (<input type="radio"/>)	
Subject : Speaker no sound

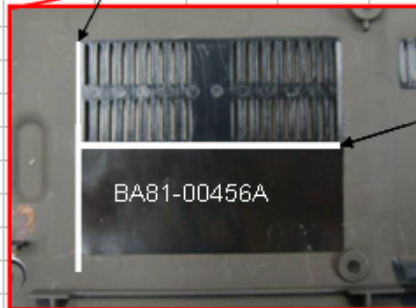
<Add insulator on C779>

Attach Insulator (BA81-00456A)
On Unit-Housing_Bottom(BA75-01856A)
Unit-Housing_Bottom(BA75-01856B)

EMI Painting Masking same line

No Vent Hole blocking

Place Insulator along Thermal vent hole
But be careful not to cover the vent holes by insulator

If the system **manufactured before Nov. '07**, add an insulator on bottom as the picture above.

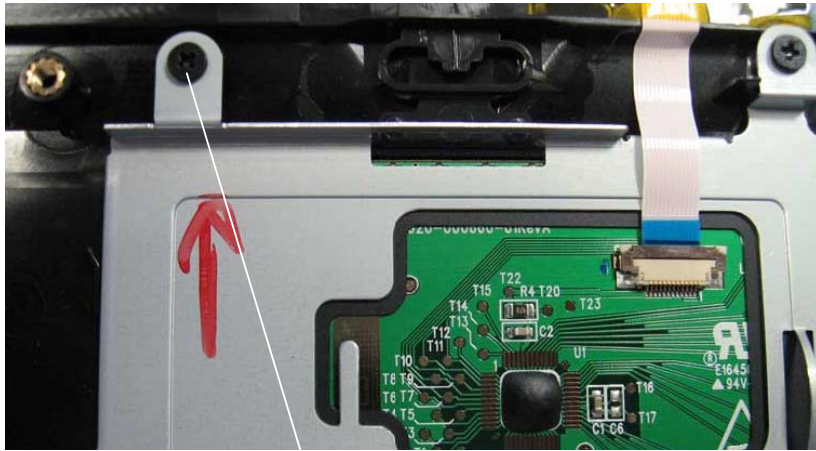
<Add insulator on C380>

- Add an insulator on C380 (applied to manufacturing as from 10th Oct.)

Insulator PN : BA81-04452A

Insulator size : 10 x 27mm, t = 0.15mm

- Extend Top plastic guide rib length (2.7mm → 3.0mm) to keep the gap between the screw and C380.

If the system **manufactured before Nov. '07**, add an insulator on C380 as the picture above.
